CASE STUDY

100mm collapsed shaft reline

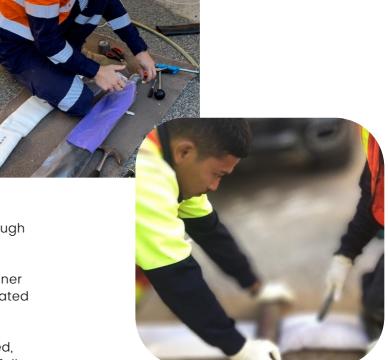
Pre CCTV Inspection

A water authority was in the process of clearing a 100% blocked property connection. Once the blockage had been cleared, a CCTV inspection was completed. The CCTV presented extensive damage and pieces of pipe missing in the jump up section. TDM was engaged to rehabilitate the property connection using a pull un place CIPP method
