Stormwater Rehabilitation

Great Eastern Highway Drainage upgrade
UV CIPP

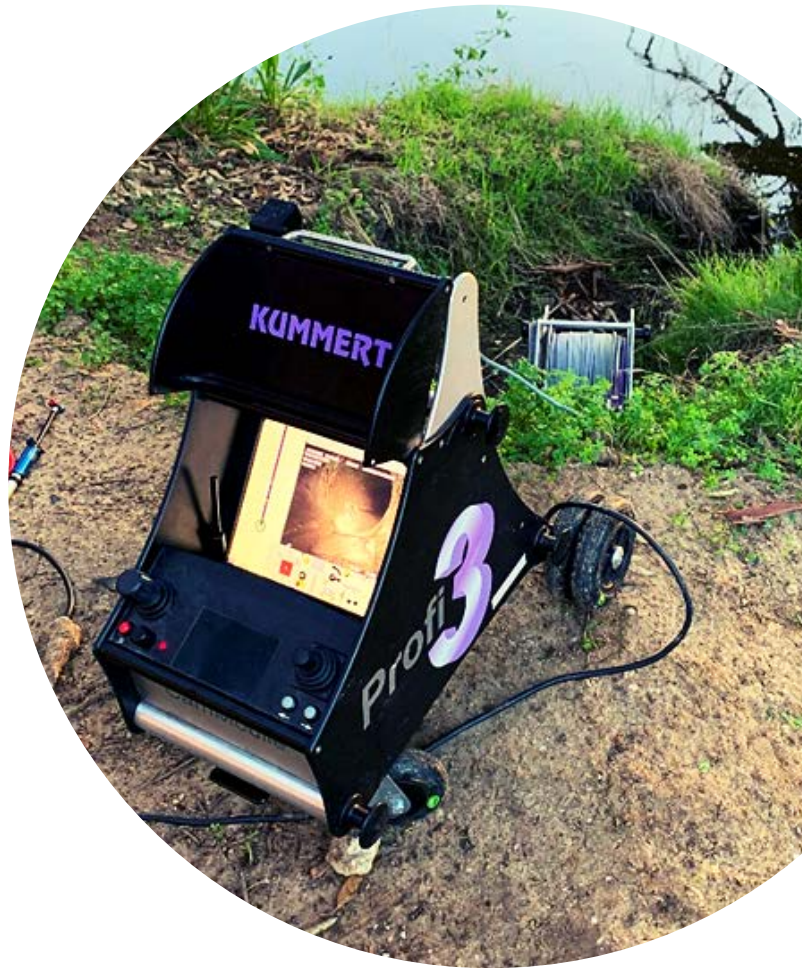
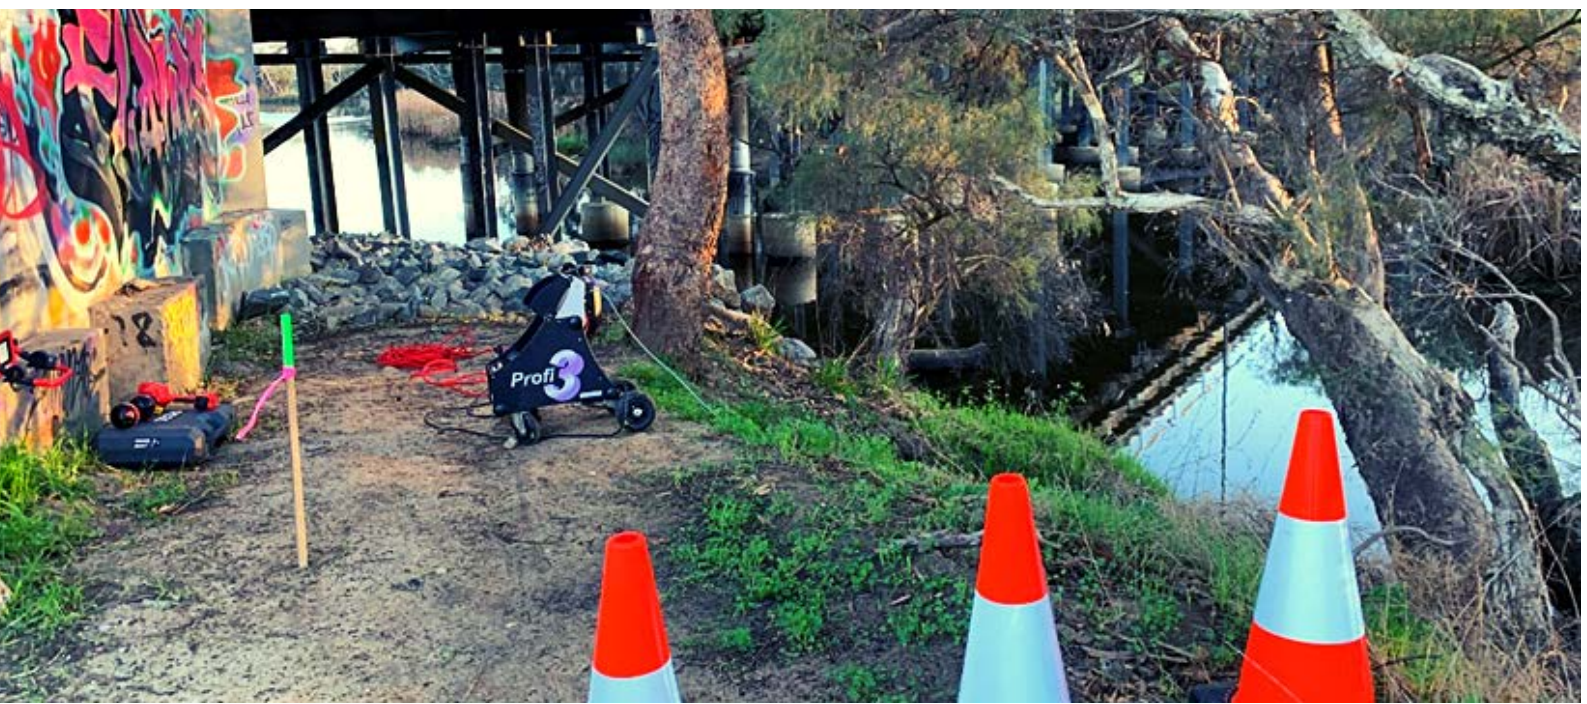
CCTV inspection was completed from the Headwall upstream to identify the broken section of the pipeline. The inspection was abandoned at 19.27m- as the crawler could not traverse further from this point due to a severe displacement within the pipeline.

The inspection presented.

- A buried pit located at approx. 1.94m from the Headwall. The pit was located and marked above ground.
- Broken pipeline from the buried pit to the 19.27m mark. – This location was located and marked above ground.

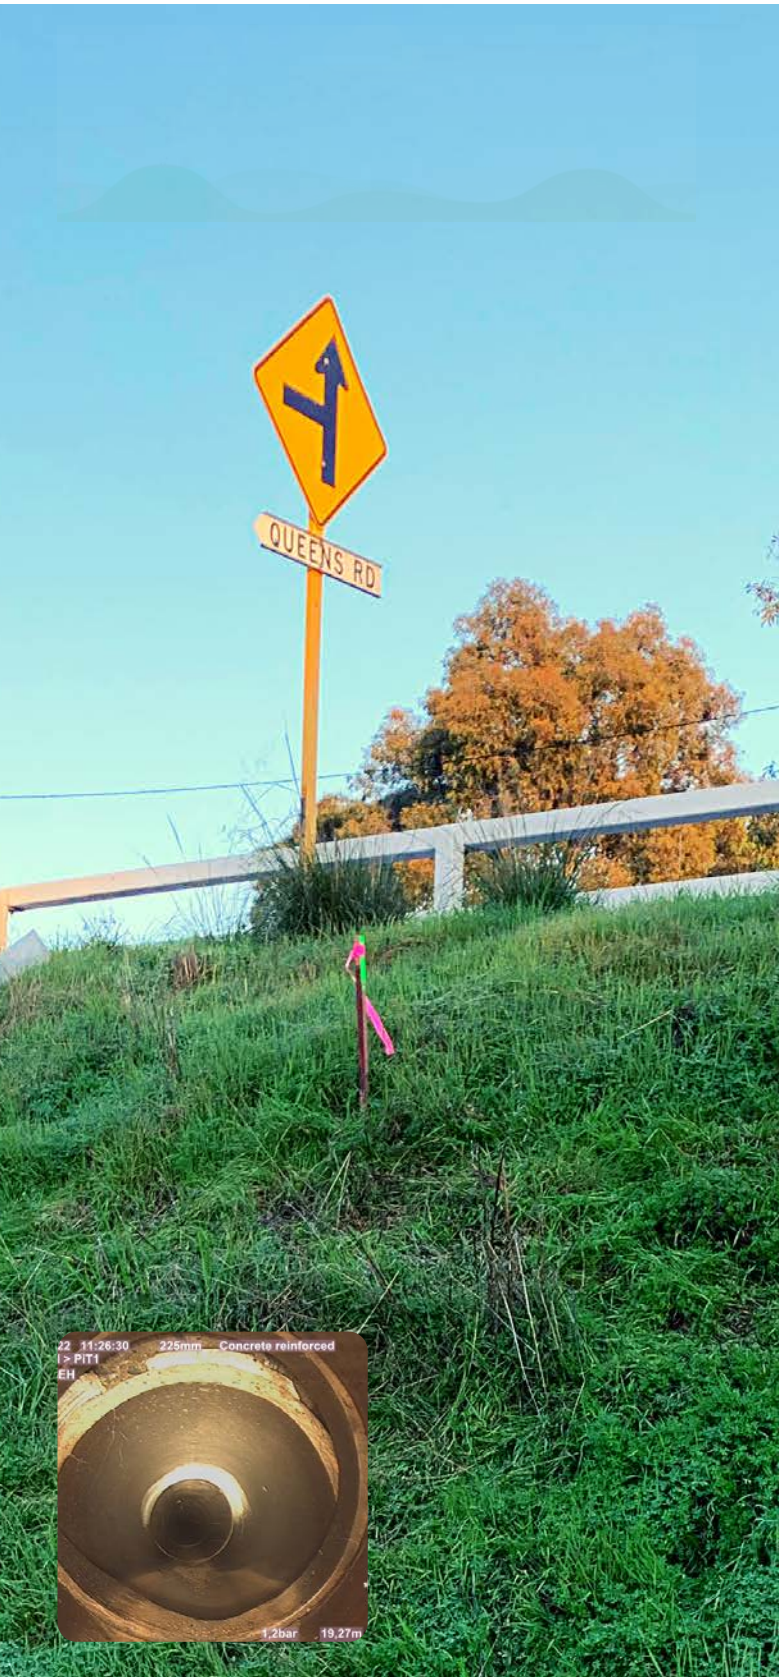
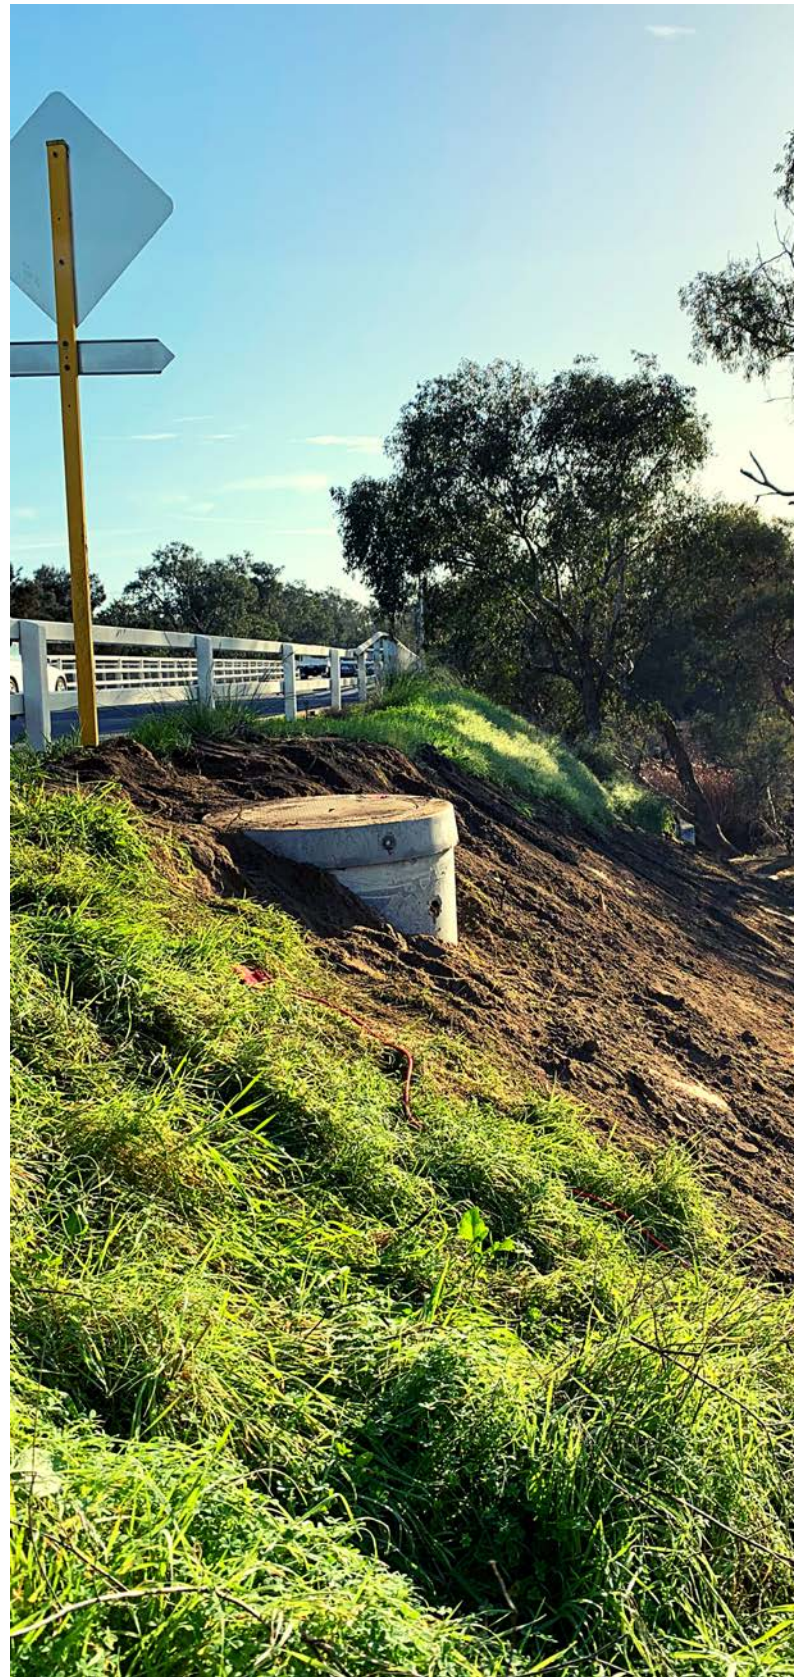
Accurate Location Services

PinPoint locating services provided by TDM ensured that the Civil Contractor made no error in locating the pipeline and installing the new AC before relining.

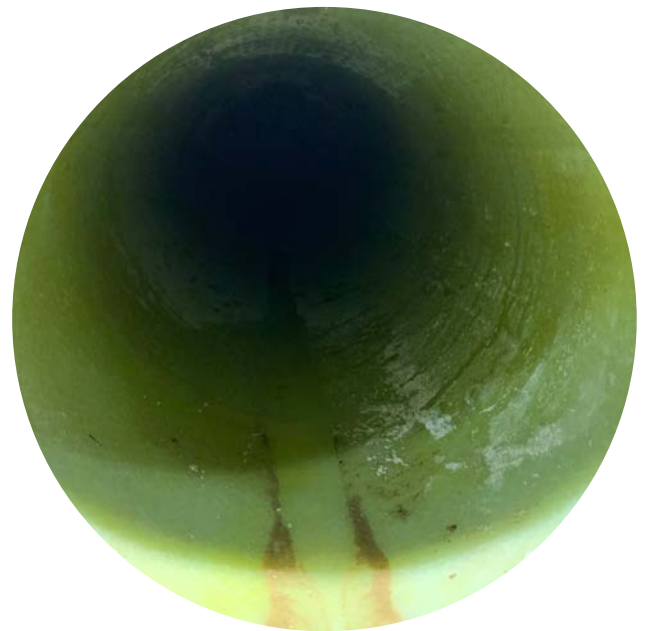
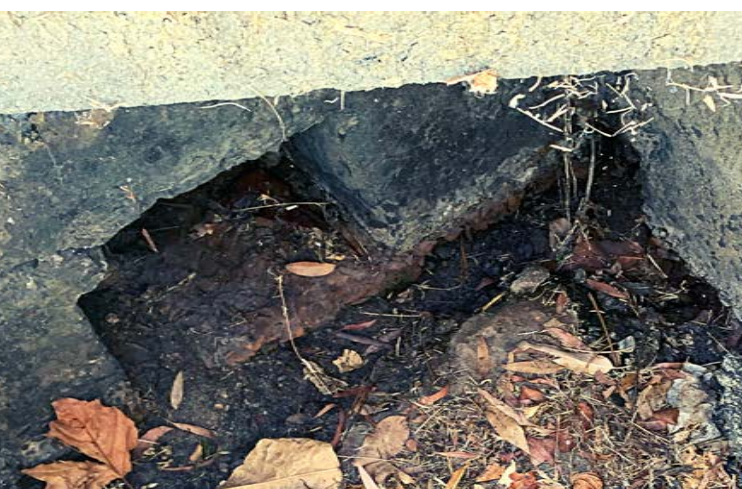
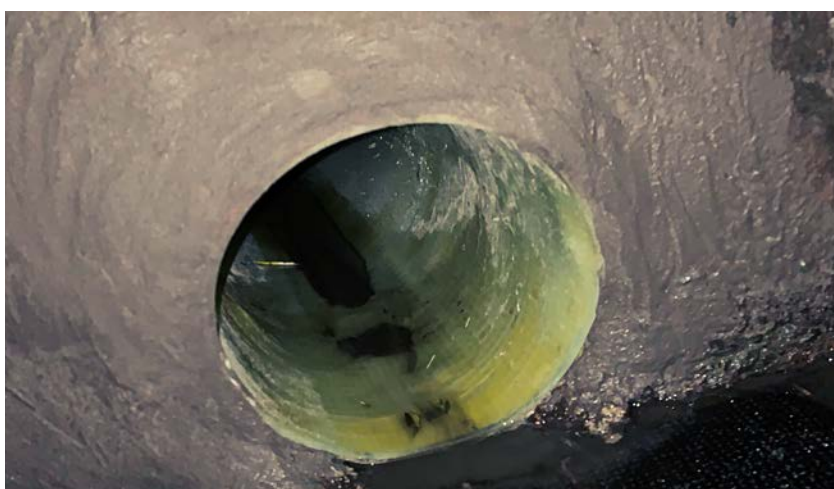
PRE AND POST UV CIPP

The CCTV inspection confirmed that the structural integrity of the stormwater pipeline was compromised by multiple fractures, cracks and other defects.

Had the pipe not been rehabilitated or replaced, there was a significant possibility of collapse and damage to the road above.

With the problematic accessibility and requirements for the minimum impact on the surrounding environment, roadway and community, TDM proposed using a (UV GRP) cured lining method.

- The whole lining operation was completed in just one night shift.
- The project's overall cost was significantly less than could have been achieved using open-cut replacement techniques.
- The carbon footprint of the project as a whole was also considerably lower.
- UV cured lining enabled work to be completed in an awkward location due to the minimal amount and portability of the equipment used.
- The high-strength Glass Reinforced Polyester (GRP) liner was designed to provide a 50+ year design life, which makes it suitable for high load situations.
