CASE STUDY

Mechanical Drainage Rehabilitation

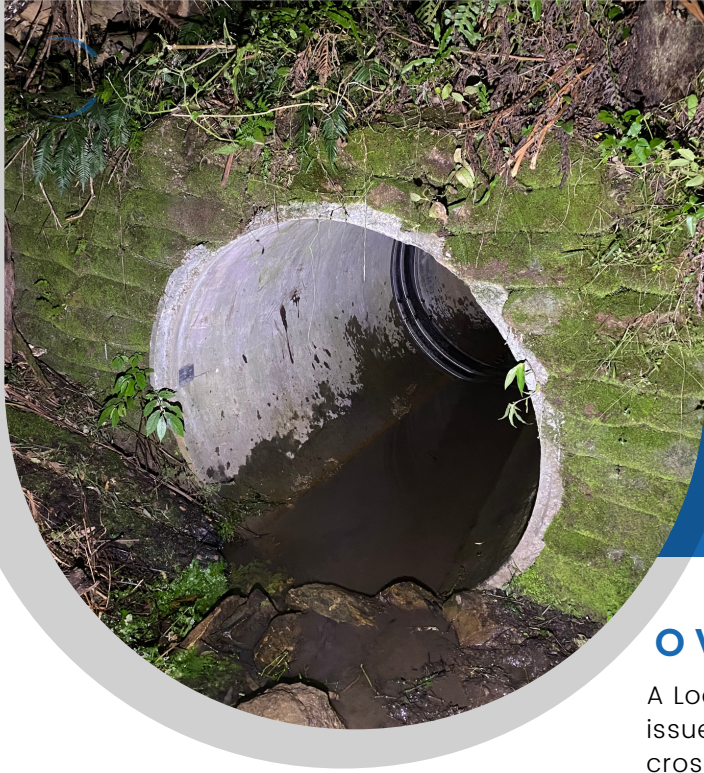
A Local Government came to TDM Pipeline Solutions with an issue of road subsidence (sinkhole) above a DN1500 road crossing culvert. TDM's culvert inspection identified extensive radial and longitudinal displacements at all joints.

With a qualified confined space entry team, TDM Pipeline Solutions installed **9 DN1500 x 500mm long structural mechanical seals** at each of the culvert joints. Installation of the seals creates a sealed barrier between the inside and outside of the pipe, stopping infill and exfiltration of the culvert, significantly reducing the chance of any future sink holes and road erosion above.
