CASE STUDY

Stormwater Drain Joint Repairs

Sectional patch repair of 200+ out of tolerance joints in drains ranging from DN375 – DN900

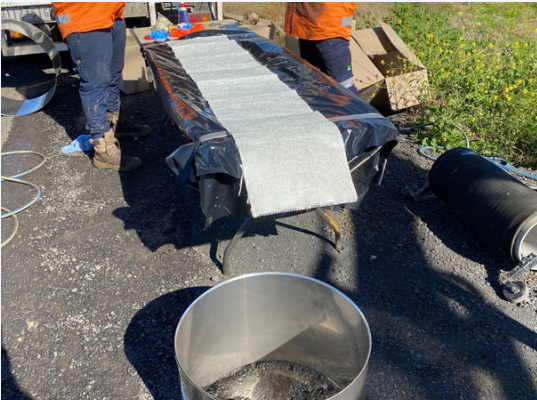
Resin-soaked fibreglass

The seals utilise fibreglass matting with an added silicate resin providing structural support to the joints. As an added benefit, the resin also infiltrates minor cracks, fractures, and defects at the joint locations, assisting in the sealing process.

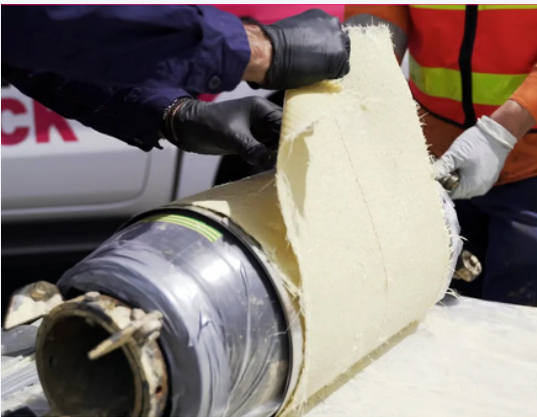
The team chose to use a self-locking, expandable, stainless steel, mechanical sealing system that could be locally sourced. This ensured the team could have the seals delivered on-site quickly. Fast curing times of around 30 minutes also contributed to the project being completed 2 weeks ahead of schedule - just 16 days for all 200 seals.

Preparing the seal

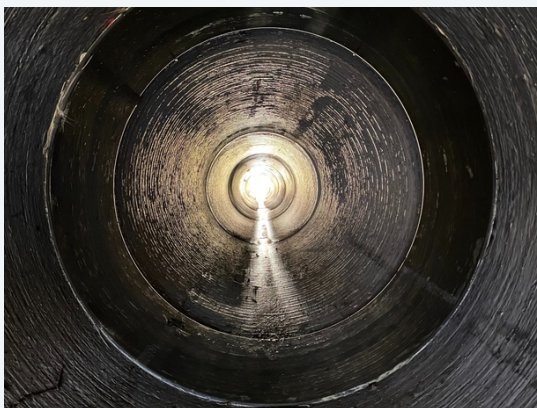
Solution Applied

Internationally sourced solutions were out of the question due to long lead times and excessive freight costs. The TDM Pipeline Solutions team sourced a local mechanical sealing system called SmartLock.
