Stormwater Rehabilitation

Great Eastern Highway Drainage upgrade
UV CIPP

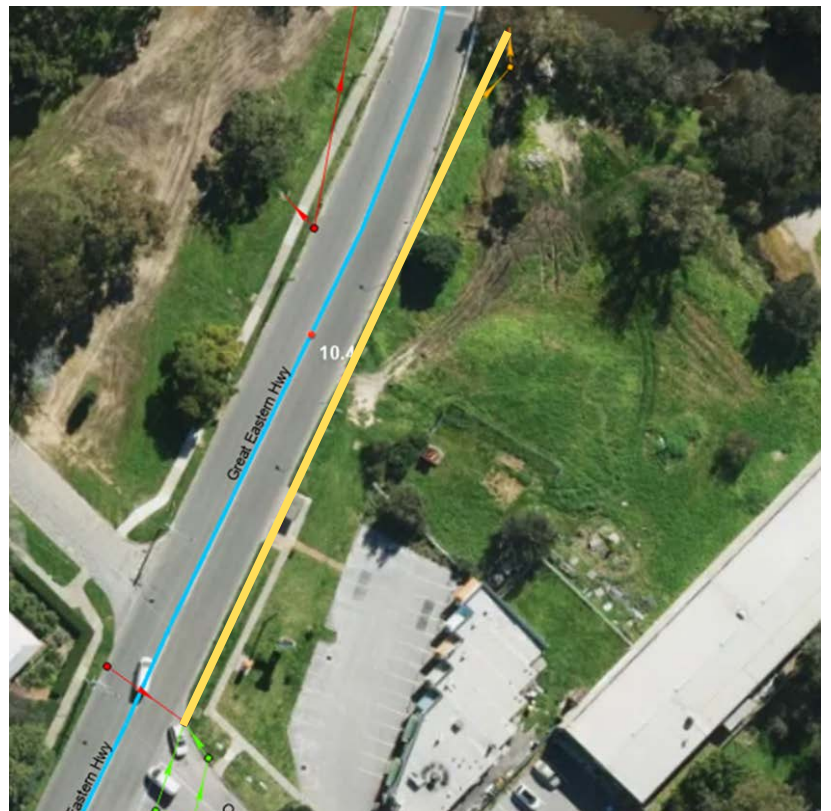
CCTV inspection was completed from the Headwall upstream to identify the broken section of the pipeline. The inspection was abandoned at 19.27m- as the crawler could not traverse further from this point due to a severe displacement within the pipeline.

- A buried pit located at approx. 1.94m from the Headwall. The pit was located and marked above ground.
- Broken pipeline from the buried pit to the 19.27m mark. – This location was located and marked above ground.

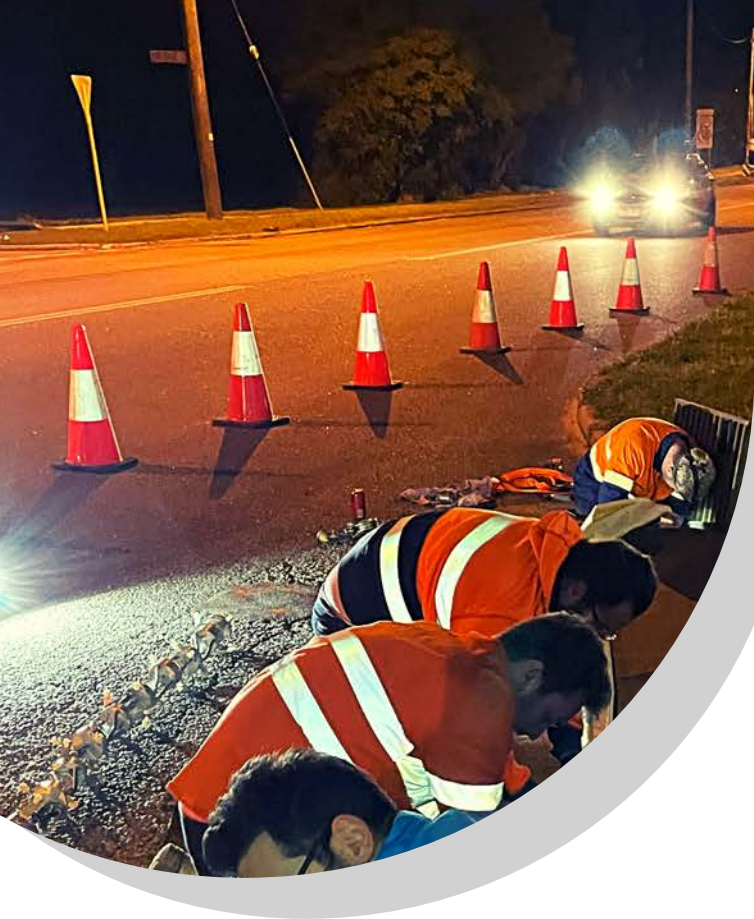
The CCTV inspection confirmed that the structural integrity of the stormwater pipeline was compromised by multiple fractures, cracks and other defects.

Had the pipe not been rehabilitated or replaced, there was a significant possibility of collapse and damage to the road above.

- The whole lining operation was completed in just one night shift.
- The project's overall cost was significantly less than could have been achieved using open-cut replacement techniques.
- The carbon footprint of the project as a whole was also considerably lower.
- UV cured lining enabled work to be completed in an awkward location due to the minimal amount and portability of the equipment used.
- The high-strength Glass Reinforced Polyester (GRP) liner was designed to provide a 50+ year design life, which makes it suitable for high load situations.
