PIPELINE
SOLUTIONS

CASE STUDY

Land Development Drainage
Condition Assessment &
Defect Repair

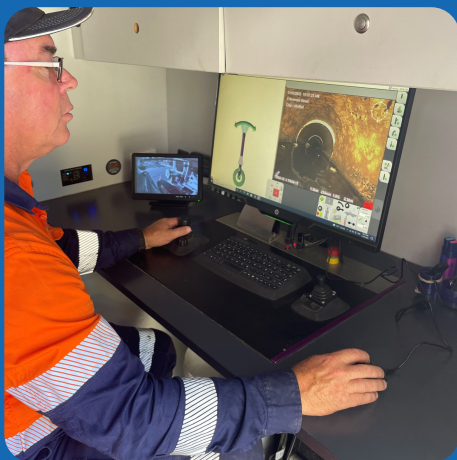
Expert CCTV technology

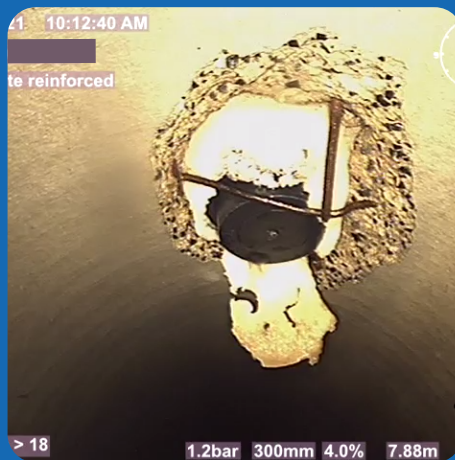
Defect identified for repair

The final scope of works included the installation of 16 Smart Lock sectional pipe repairs to seal JDR in drains ranging from 525mm up to 825mm in diameter and a total of 31 metres relining across 4 sections with a CIPP resin-based liner.
