PIPELINE
SOLUTIONS

END OF LINE RELINE

COUNTRY NSW DEAD END RELINING

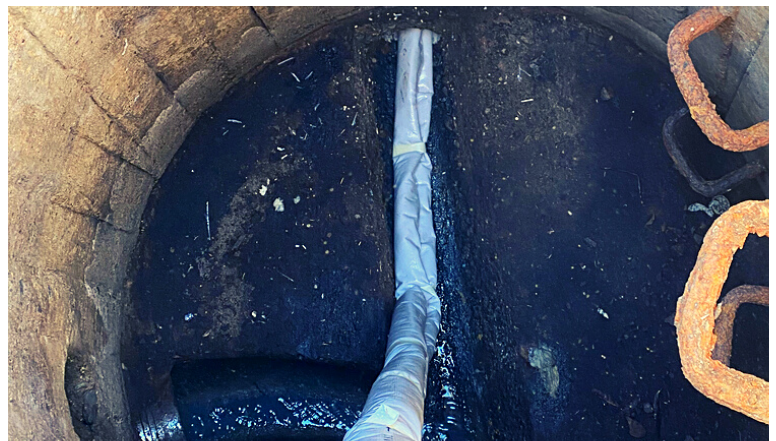
IMPREGNATED LINER INSERTION INTO RETIC

With a 3 man relining crew TDM Pipeline Solutions were able to clean, CCTV and reline the 3 end of lines in 4 days. This was completed by use of epoxy impregnated felt liner and installed through the existing infrastructure (manholes, Boundary traps and Junctions). No excavation or digging was required to complete the package of works.

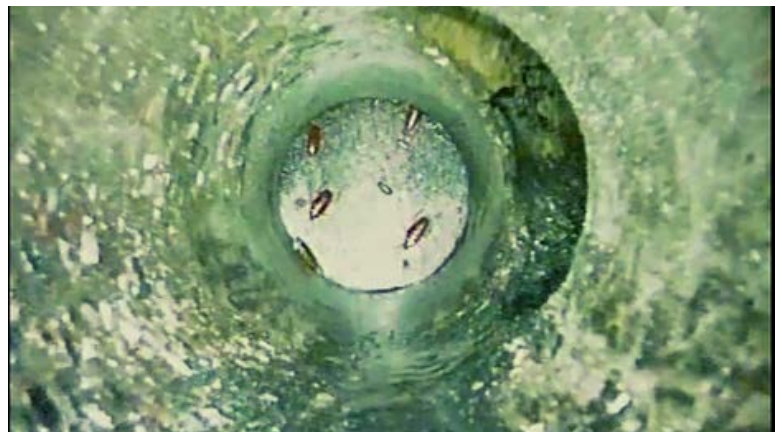
PRE CCTV - LAST JUNCTION BEFORE END OF LINE (EOL)

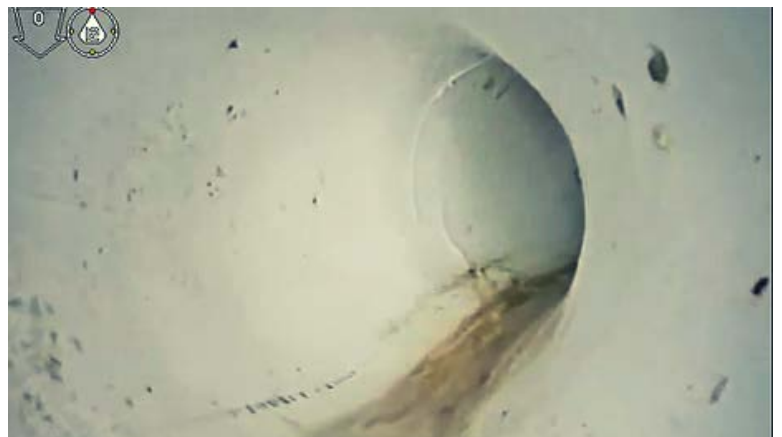
POST CCTV LAST JUNCTION (EOL) CONVERTED TO BEND
